## Water Conservation

# Featuring Aqualastic™

Roza Irrigation  
District Main Canal  
Rehabilitation Project

Numerous cracks  
in 7,200 Linear Feet  
in main canal

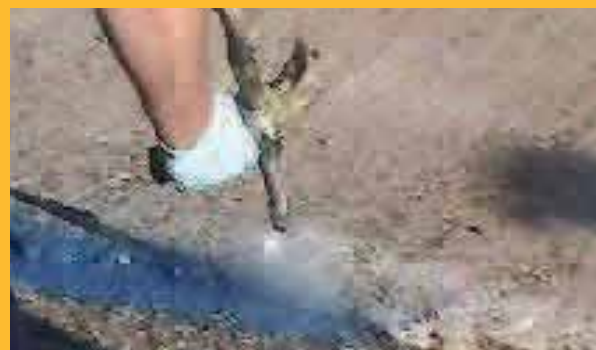
Two 3,600 linear ft. sections of the main canal had substantial leaks due to a number of cracks in the concrete. The cracks were caused by expansion and contraction from seasonal freeze thaw cycles.

Aqualastic™ bridges cracks to accommodate expansion and contraction from freeze-thaw cycles unlike conventional caulk/joint fill products.

The project involved spray applying Aqualastic™ on the cracks, which has now been successfully fielded for 9 years. The objective was to eliminate enough leakage, before the next water shortage, to make application of the product cost effective. The project would have to eliminate at least 88% of leaks to be successful.

Project preparation entailed sand blasting a 3 to 4 inch wide strip on each side of the cracks in the concrete. The contractor then applied approximately 80 mils

(2 mm) of Aqualastic™ to the cleaned strips, bridging the cracks to create a water-tight seal to eliminate the water loss.

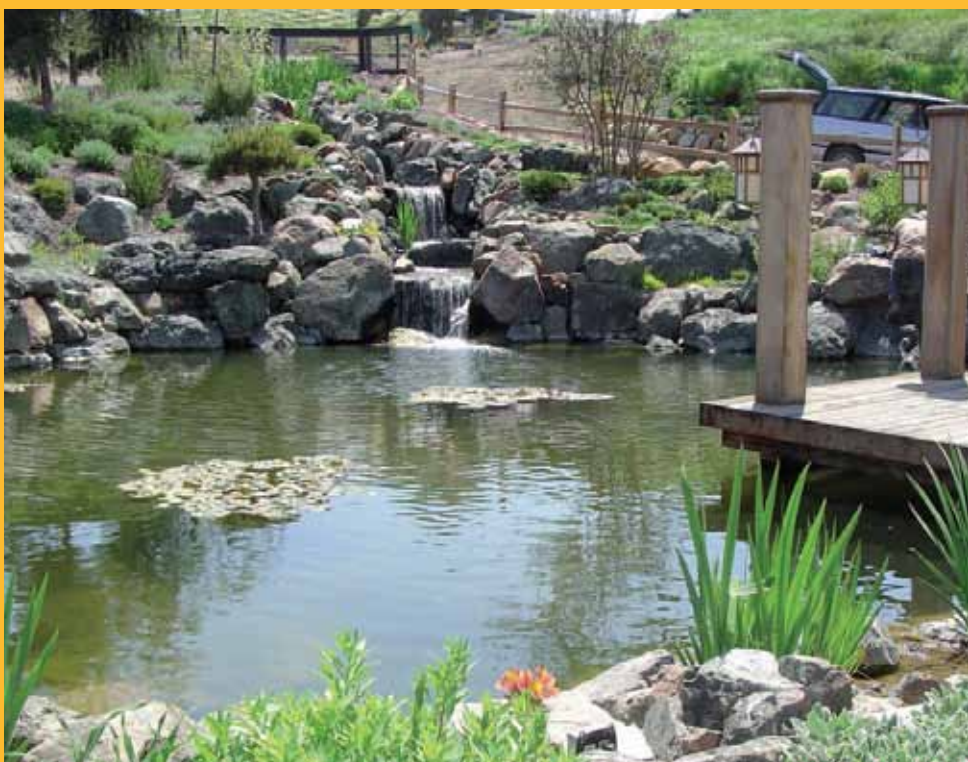
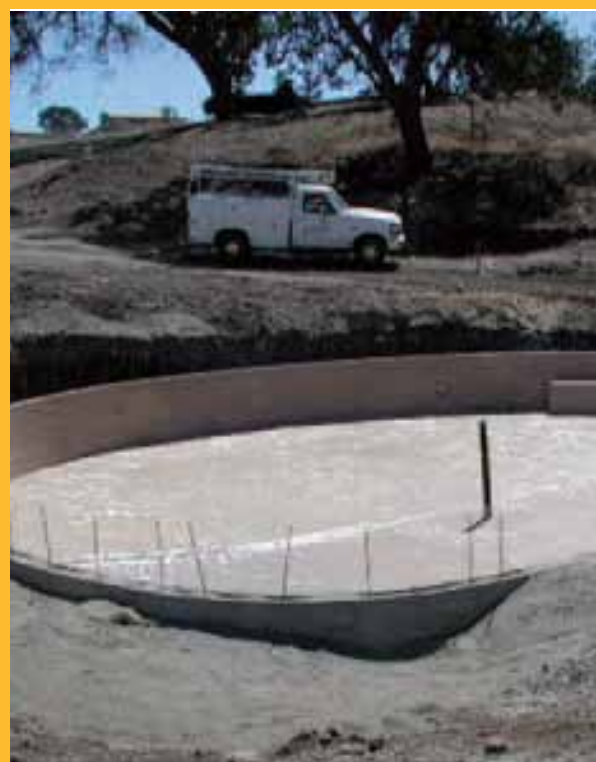
Many factors are considered when selecting a pond liner: marine life safety, chemicals leaching into the water, and avoiding unsightly liner folds that accumulate gas pockets which may cause bacterial and fungal infections. If necessary, the material needs to be strong enough to handle high pressure washings.

The liner would be required to adhere to a variety of substrates and blend in with the environment. It also needs to be able to handle heavy boulders placed over it without tearing or fatiguing.

The contractor lined the pond basin with Amoco 1198 geo-textile fabric. Sand colored Polyshield HT™ polyurea was spray applied on top of the geo-textile fabric at 130 mils (basin) and 80 mils (perimeter walls). The coating was successfully tested for water leaks. Placement of heavy boulders did not damage the liner.

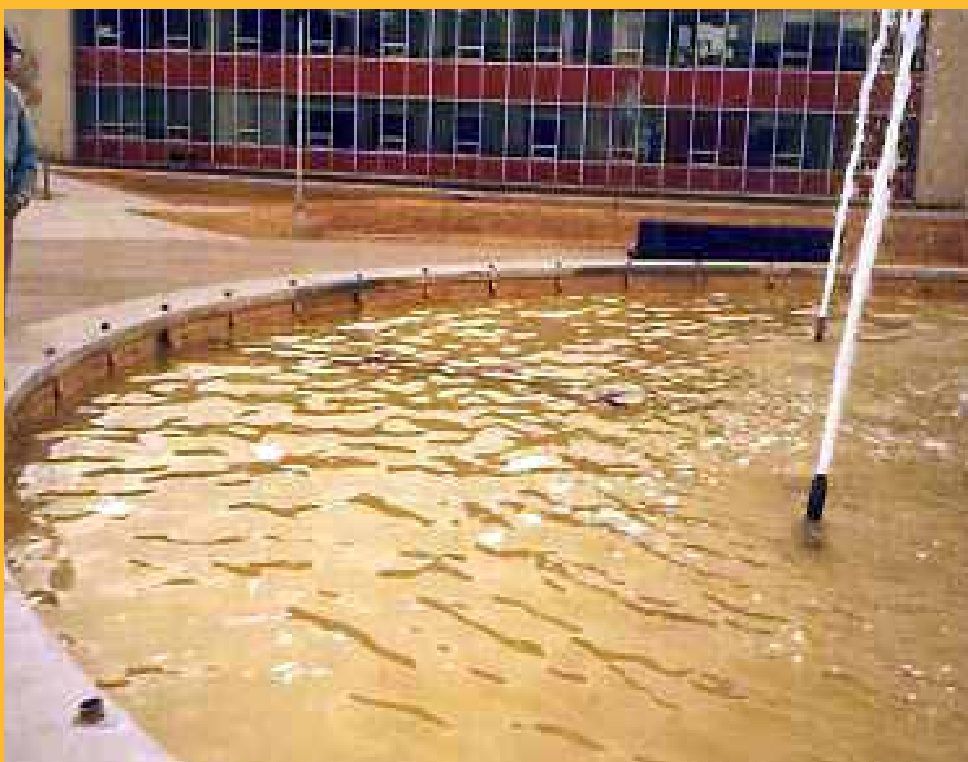
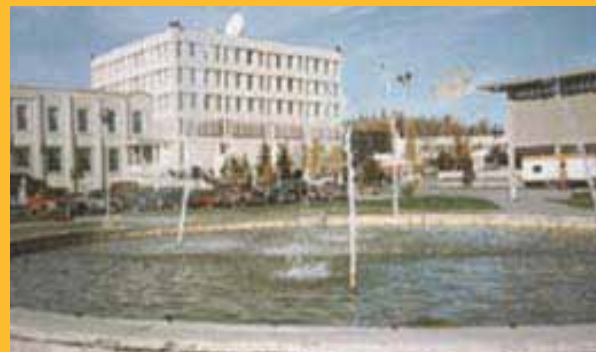
Microscopic cracks were found in the original epoxy coating of a 3,000 sq. ft. water feature, "The Fountain of the Flags" at the University of Alaska, Fairbanks. These cracks were causing leaks with a daily loss of thousands of gallons of water. The water was making its way into the plumbing corridor under the fountain, which potentially could be a serious and expensive problem if left untreated.

They chose Polyshield SS-100® because it forms a seamless, crack-bridging membrane that prevents water leakage. With high pigment added for color stability, Polyshield SS-100® was applied at 60 mils. The polyurea protective coating created a watertight seal.

University officials were relieved to have a reliable waterproof coating in place to protect the water feature's concrete surface. In a follow up inspection (summer 1996) the coating was performing well, with no loss of water and no discoloration.

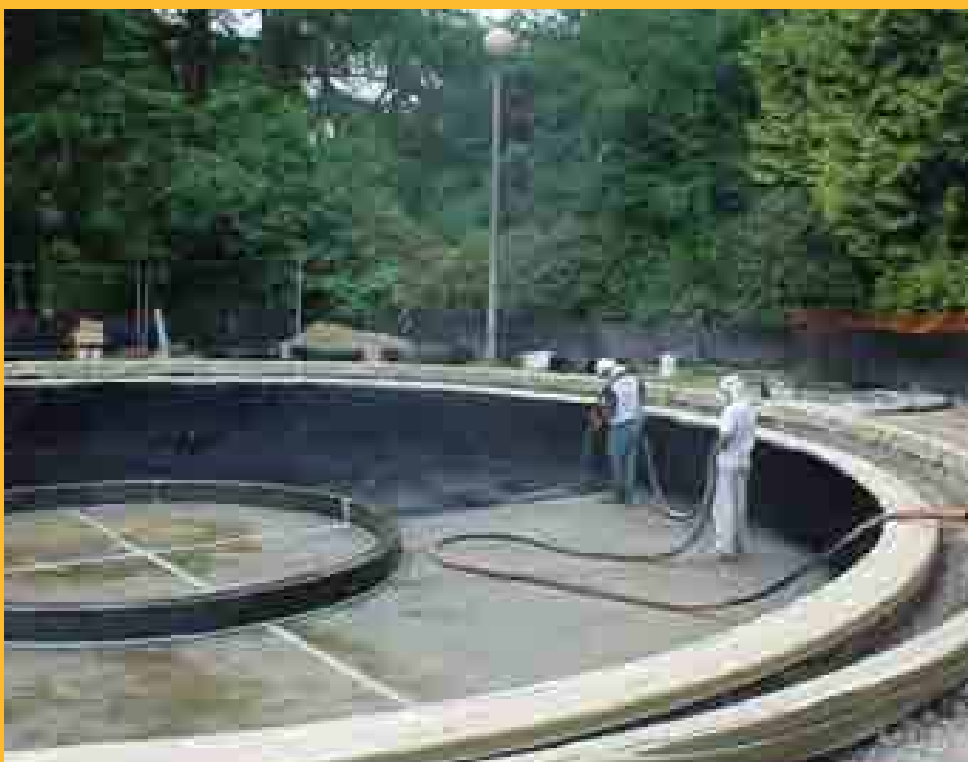
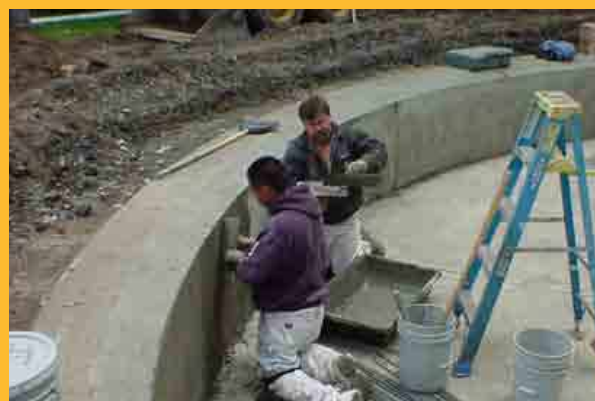
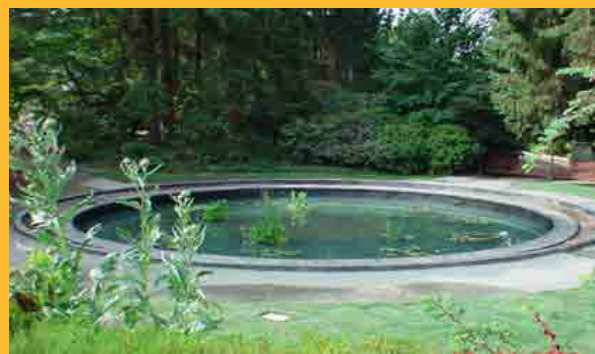
100-year old twin concrete lily ponds in the heart of Seattle's Volunteer Park fell into disrepair. Once the concrete ponds were damaged beyond repair, they were drained of water and lilies, and sat unused for over twenty years.

SPI's Polyshield SS-100® was chosen because of its durability, elongation, and hydrophobic properties allowing for application to damp, cool surfaces. The old concrete surface was prepared by pressure washing and concrete patching. The concrete surface was primed with SPI's Polyprime-100™. Next Polyshield SS-100® was applied at thickness of 125 mils.

The ponds were inspected by a Seattle Parks and Recreation official two years later. There were no leaks and the coating was still firmly adhering to the concrete.

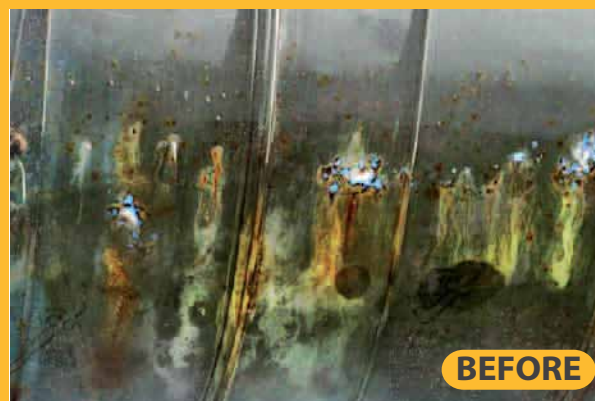
Three galvanized steel flumes originally constructed in 1984 were corroded and leaking. The replacement of the flumes and other repair methods were evaluated, but not feasible due to cost. The irrigation district chose Polyshield SS-100® for its corrosion resistance, its ability to bond to steel, and it was determined to be the most economical solution.

Preparation of the flumes consisted of grit-blasting a 3 to 4 mil anchor profile. One flume was so badly corroded that blasting created holes in the steel.

Polyshield SS-100® was used to coat the outside of the flume.

This section then acted as a mold-form for the interior to be blasted and sprayed. The result was a new flume section consisting of SPI Polyshield SS-100® applied at 50 mils to the exterior and 100 mils on the interior of this section.

In 2008, Tom Matheson of Matheson Painting re-inspected the flumes. Matheson stated that initially the Polyshield SS-100® system was to be a temporary fix. Nine years later, not having to replace the steel, it is estimated to have saved the owner over \$3,000,000.00. Matheson went on to say, "There is no sign of wear, and the product is performing like new."

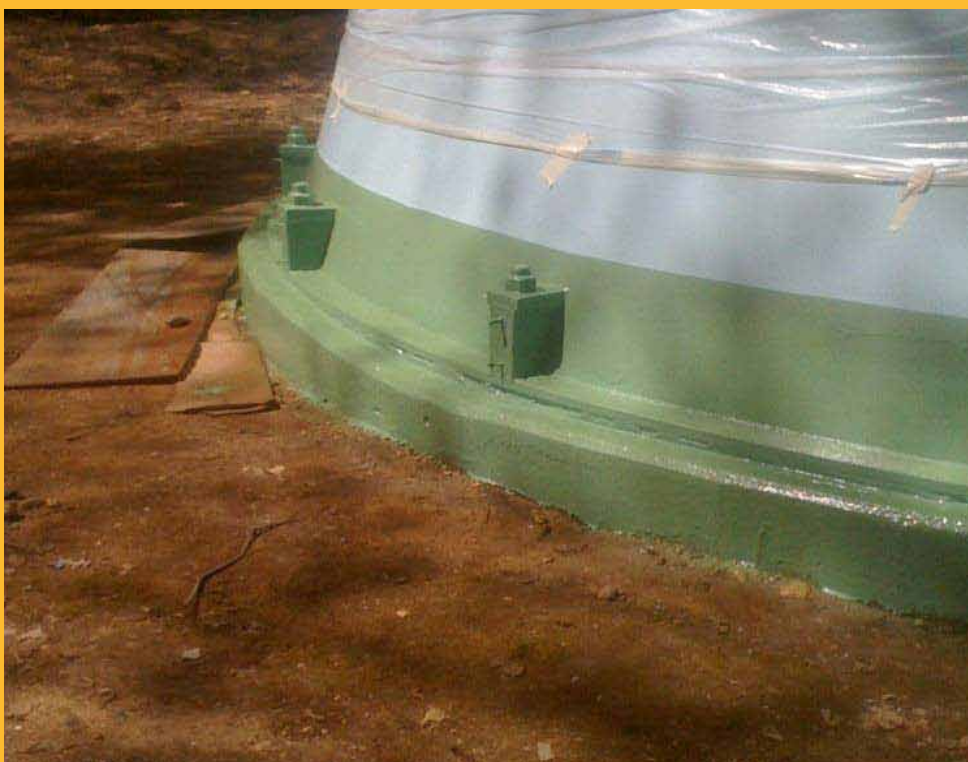
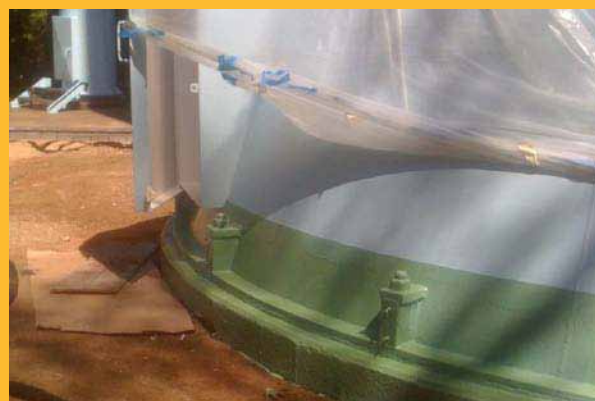
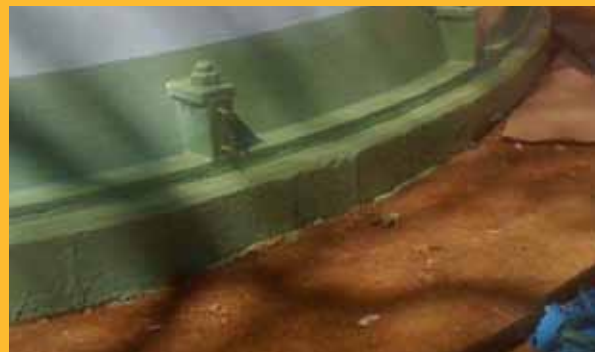
The Water Authority of Oyster Bay, NY wanted to eliminate the moisture zone between the concrete and steel base of a water tower. Condensation would occur, due to the humid climate, and run down the side of the tank, gathering at the seam between the concrete and steel. This moisture problem was causing the concrete to spall and the steel to deteriorate from rust.

Nick Pjatikin, of Delphi Engineering, installed Aquaseal Synergy Series™ polyurea using SPI's LPG™ (Low Pressure Gear) mobile equipment. The polyurea seamless liner bridged the steel tank, concrete foundation, and anchor bolts. This provided a seamless, water-proof, protective liner that fully adhered to all of the substrates.

The concrete was media blasted to remove all debris particles and damaged concrete. The freshly painted steel was scuffed to take off the shine and provide an anchor profile to promote better adhesion.

The applicator spray-applied 80 mils of Aquaseal™ polyurea. Finally, a two part urethane paint was added for U.V. color stability and aesthetic purposes to color match the rest of the tank.
