# **Secondary Containment**

# Featuring Polyshield HT™

Secondary Containment for Hazardous Waste Drum Storage Pads

**Great Western Chemical Tank Farm**

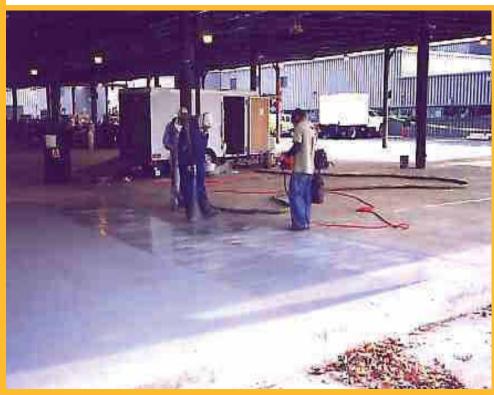
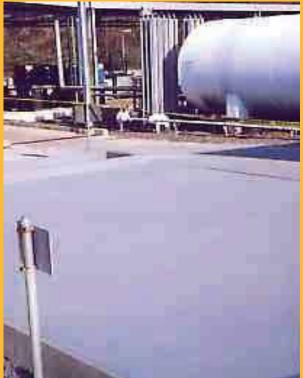
Concrete storage pads with curbing (used to store hazardous waste drums) developed cracks throughout the surface. These cracks allowed water to contaminate the soil. The concrete pads were originally coated with a clear sealer that was failing.

The concrete surface was prepared using a high pressure water blaster (40,000 psi) to

remove the failing sealer and to create a profile for optimizing adhesion. Polyshield HT<sup>TM</sup> with AE-4 (Adhesion Enhancing Formula) was applied at 50 mils, eliminating the need for a primer. This was followed by an additional top coat of the polyurea into which a sand aggregate was broadcast in the coating to provide a skid resistant surface.

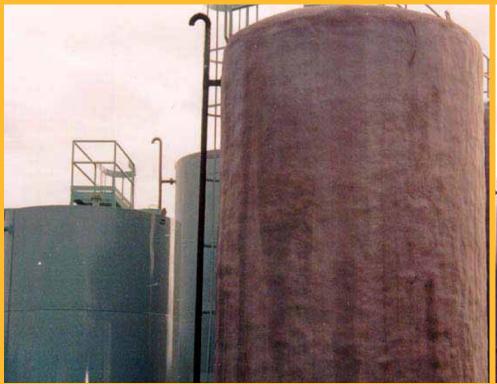
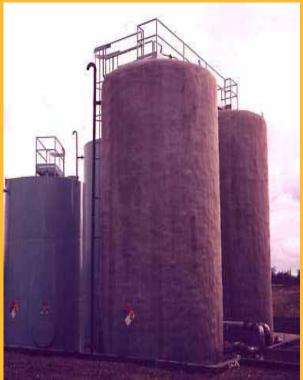
Great Western Chemical needed to insulate two storage tanks. Additionally, they required a protective liner on the outside of the insulated tanks, and a secondary containment system to protect the ground soil in the event of any leak or spill. The facility also experienced issues with birds pecking at foam insulation to burrow in for nesting purposes.

Two 30,000 gallon tanks were cleaned, then sprayed with six inches of two pound density polyurethane foam. Then a protective coating of Polyshield SS-100® polyurea, High Pigment-UV Aluminum was applied at 40 mils to the foam surface. In addition to the tanks, the concrete dikes (broom finished) were sprayed with black Polyshield SS-100® at 40 mils to provide a reliable secondary

containment liner.
