Copper Mine Corrosion Protection

Montana Resources
Copper Mine Sludge
Processing Tank Liner

Coal Mine Corrosion Protection

Leak Prevention

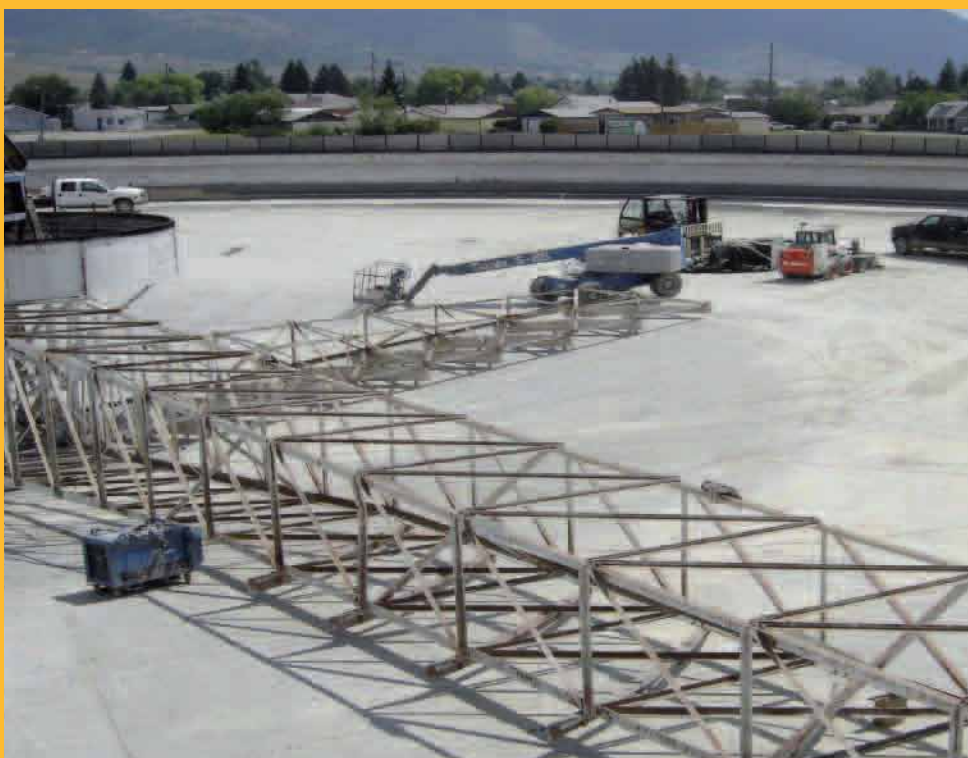
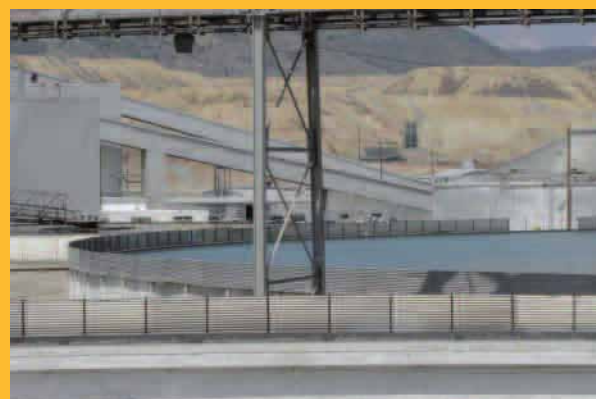
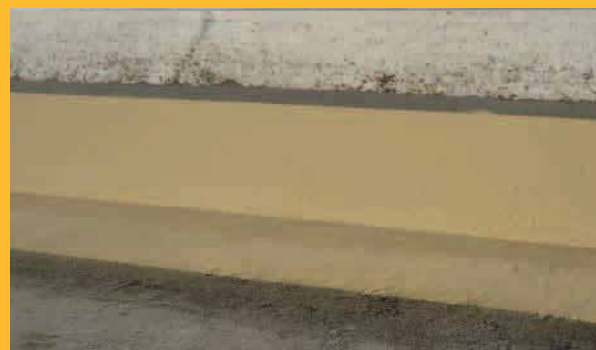
The Montana Resources copper mine sludge-processing tanks were deteriorating and leaking due to severe abrasion and corrosion issues. Sludge (sand & water) is pumped in from the mine into storage tanks. Sand and water are separated with a large spinning mechanical boom that forces the sand through a cork screw drain at the bottom of the tank. The interior bottom-edge of the tank walls were built with a 16" concrete curb and 3' steel plate liner. The concrete curb allowed the mechanical boom wheels to move around the tank edges. This process created significant abrasion and corrosion damage resulting in several leaks around the tank edges. Other expensive epoxy coatings were used in the past, but failed in less than one year. Montana Resources needed a tough and reliable solution in place to keep operations moving at full capacity.

SPI's K5™ polyurea coating was chosen because it has the strongest abrasion resistance in the protective coating industry. The steel plate and concrete curb surfaces were sand blasted to remove the failed epoxy coating. Polyprime-100 was applied to seal the concrete surface. K5™ polyurea with AE-4 (adhesion enhancer) was applied to the concrete and steel surfaces at 130 mils. The AE-4 additive eliminated the need for a primer and allowed for immediate spraying to the steel substrate, saving time and preventing rust from setting in.

Montana Resources drained the tank for inspection after being in service for 90 days. There were no visible signs of any damage. The K5™ coating performed so well, Rowell Spray Systems was awarded several more tank projects.

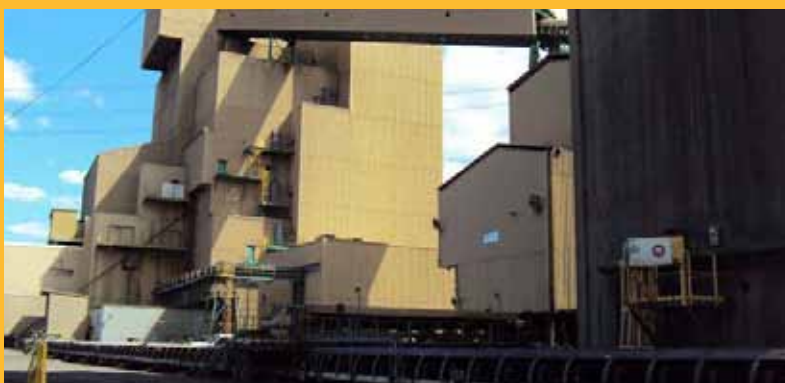
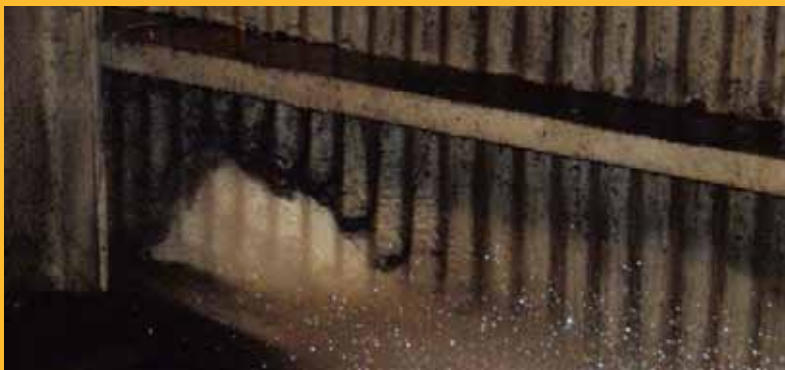
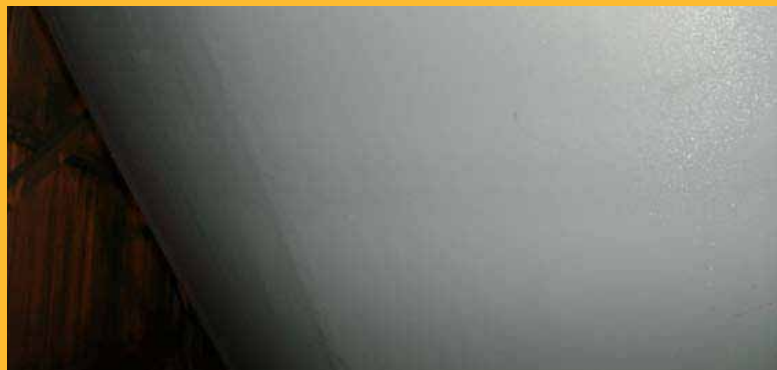
The coal mining process creates an extremely corrosive environment that accelerates the breakdown of steel from rust. CONSOL Energy, the largest producer of high-Btu bituminous coal in the United States, needed a durable coating system to protect parts of their coal mine steel infrastructure. Replacing sections of steel is a very expensive process, costing approximately \$150 per foot, not including labor and safety expenses. Other important project requirements included: minimizing any fumes to maintain internal air-quality, using a fast curing product that would not interrupt 24/7 mine operations, and be able to withstand power washing to remove daily coal residue build-up.

The steel substrates were cleaned and sand-blasted to provide a 6 mil anchor profile for adhesion purposes. Next, the applicator spray-applied 80 mils of Polyshield HT™ with AE-4 (adhesion enhancer) to the steel surface. Using AE-4 eliminated the extra step of applying a primer, saving time and money.

CONSOL Energy officials are very excited with the performance of Polyshield HT™. Mine maintenance personnel are able to power wash the corrosion-resistant coating to remove coal residue and dust. They now have a reliable solution in place that will extend the service life of their multimillion dollar investment. This substantial cost-saving solution also lowered their eco-footprint by avoiding the need to replace parts of their steel infrastructure.

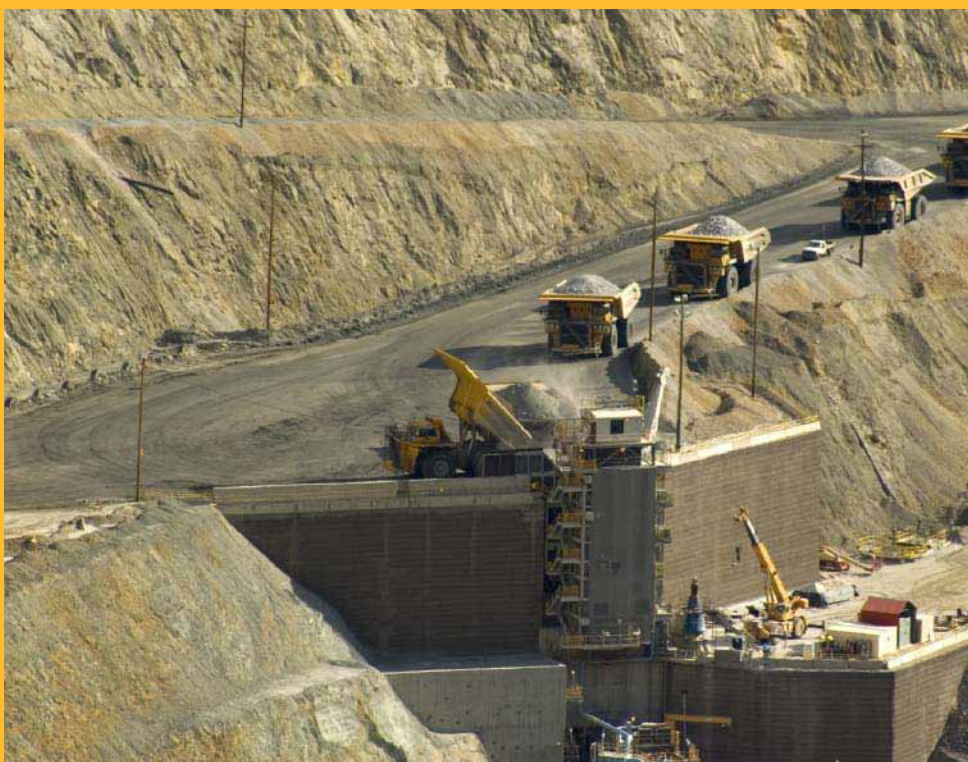
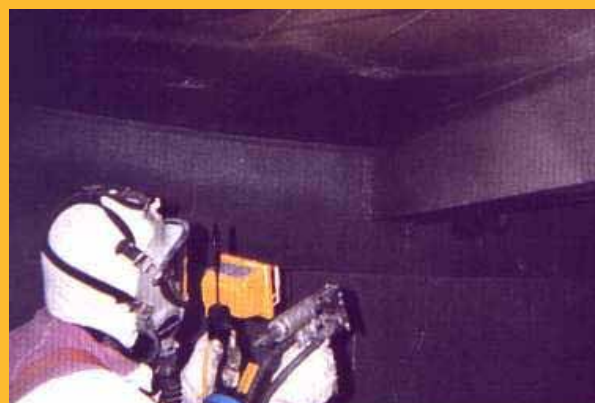
Mine personnel discovered leaks in two concrete storage tanks. The tanks were originally used to store lime solution and were being converted for deionized boiler water storage. When the tanks were first converted the mine owner lined the floors and walls with an epoxy coating. Subsequently, when the tank was filled with water, leaks were observed. The epoxy had failed and they needed a superior solution.

contacted Hydrodynamics to find a coating solution. Hydrodynamics recommended SPI's Polyshield SS-100® polyurea due to the product's water resistant and elastomeric properties. The inside of epoxy-coated concrete storage tanks were grit-blasted, followed by epoxy grouting in areas that were cracked. Then Polyshield SS-100® polyurea was applied at 60-80 mils (1½-2mm) on the tank floors and walls.

In October 1996, the owner was contacted regarding performance of the tanks. SPI was informed that the Polyshield SS-100® polyurea coating was performing well and there were no visible signs of damage.

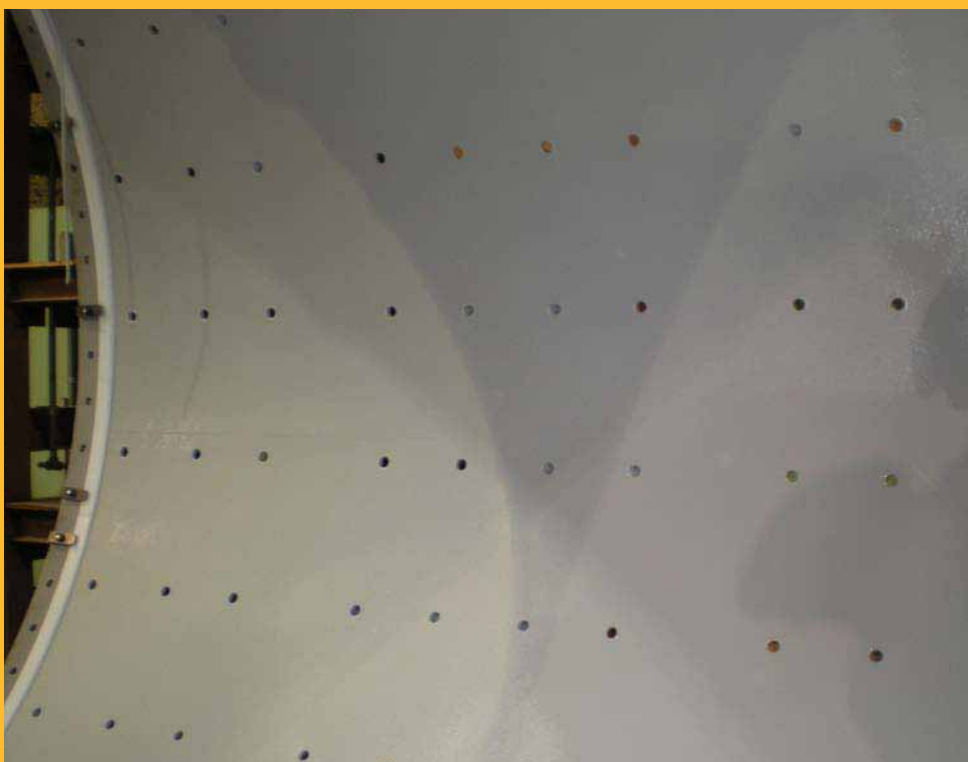
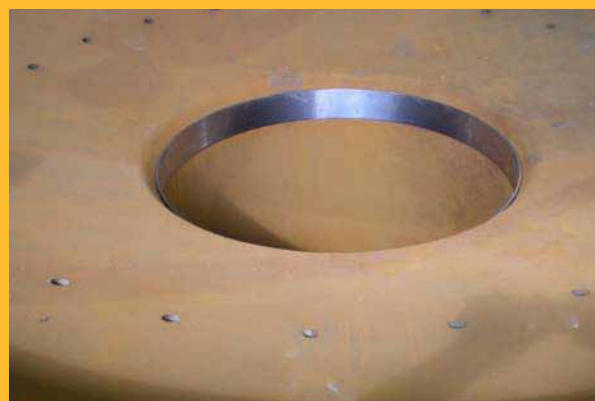
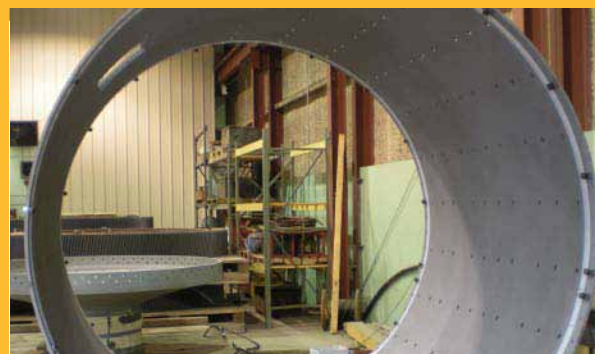
The inside of the steel ball mill drums needed protection from corrosion and the sand & metal balls used to crush the sludge material. Extreme service conditions required a coating that would properly adhere to the surface, while providing good abrasion and corrosion resistance. Extending the service life of the retired ball mills would provide substantial cost savings for the refinery, eliminating the need to buy expensive new steel material.

ultimately selected due to the coating's good corrosion and abrasion resistance. Utilizing the NACE-SSPC-10 near white metal surface preparation standard, the applicator abrasive blasted the steel surfaces to remove years of built-up corrosion damage.

Next, SPI's Watershield III™ polyurea coating, with AE-4 (adhesion enhancer), was spray-applied at 80 - 125 mils. The AE-4 admixture increases adhesion to properly prepared substrates and eliminates the need to use a primer.
