Corrosion Resistance

Featuring Polyshield HT-101™

Proiect:

Steel Cooling Towers

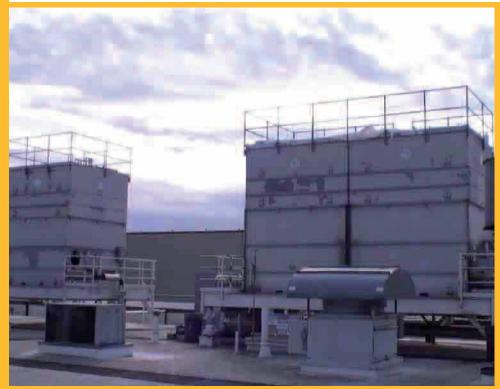
Steel cooling towers at a major airplane manufacturing plant in Washington State are constantly exposed to the harsh regional environment. As a result, the towers quickly started to rust and corrode. To minimize the facilities downtime, the owner needed a long-term solution, with a fast turn-around time.

As always, proper surface preparation was critical prior to the coating application. Surface preparation included pressure washing, and grinding the steel substrate to remove existing rust and corrosion. To ensure adhesion, the substrate was primed with SPI's EP-100TM (Epoxy Primer).

SPI's self-leveling EPL-8TM was applied to the hard-to-reach areas. Polyshield HT-101TM was then applied at a thickness of 60-80 mils. Each cooling tower took an average of 2-3 days to completely prep, prime, and coat with Polyshield HT-101TM. Once applied, Polyshield HT-101TM's fast-set physical properties allowed for a quick return to service time.

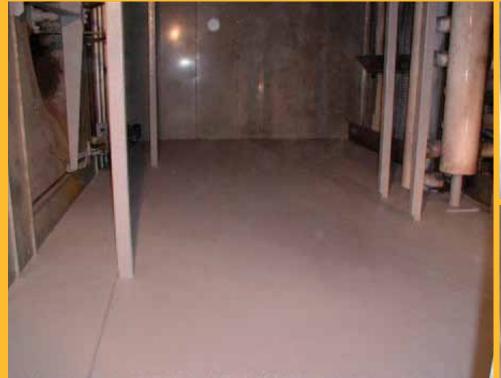
The HVAC air handling systems at a major pharmaceutical laboratory were severely corroded and began to leak. The air handling units had previously been coated with epoxies and needed recoating, due to numerous failures.

The project owner decided to use SPI's Polyshield HTTM polyurea because of the product's water resistance and high elongation properties. Before the polyurea coating could be applied, the failed epoxy coating had to be removed, along with a great deal of rust and corrosion. Grinders were used to remove the epoxy coating and corrosion, and to provide an anchor profile for proper adhesion to the

substrate. Polyshield HTTM with AE-4 (adhesion enhancer) was then spray applied at a thickness of 60-80 mils. The product's rapid curing properties allowed the air handling units to be quickly returned to service.

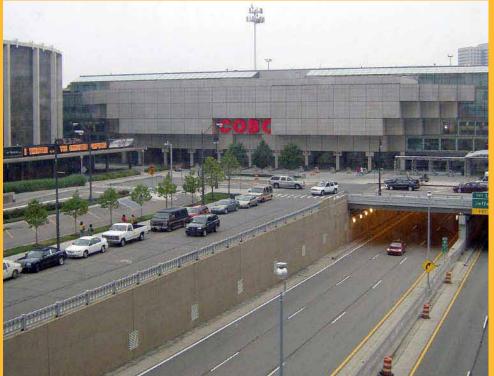
The City of Detroit is home to the expansive and impressive Cobo Center (formally Cobo Hall). On top of this giant 2,400,000 sqaure foot facility are 22 air handling buildings that contain the HVAC units required to keep the thousands of annual patrons cool and comfortable. This world class facility had serious problems when the air handling buildings started to leak water. The water was dripping down onto the venue floor and event attendees. Cobo Center management made several unsuccessful attempts to seal off the air handling buildings.

The city chose Polyshield SS-100® polyurea to coat the air handling building floors and walls. Polyshield SS-100® was the best solution because of its durable, seamless, and water-resistant properties.

After proper surface preparation, the floors and walls of the air handling buildings were coated with 64 mils of Polyshield SS-100®. The floors were then flooded for leak testing with 1" of water and left alone for 6 hours. There were no leaks in any of the 22 air handlers.
