Building Roof

Featuring Polyshield HT-101™

Project:
The Marlborough House

System:
POLYSHIELD HT-101™ Polyurea
100 mils

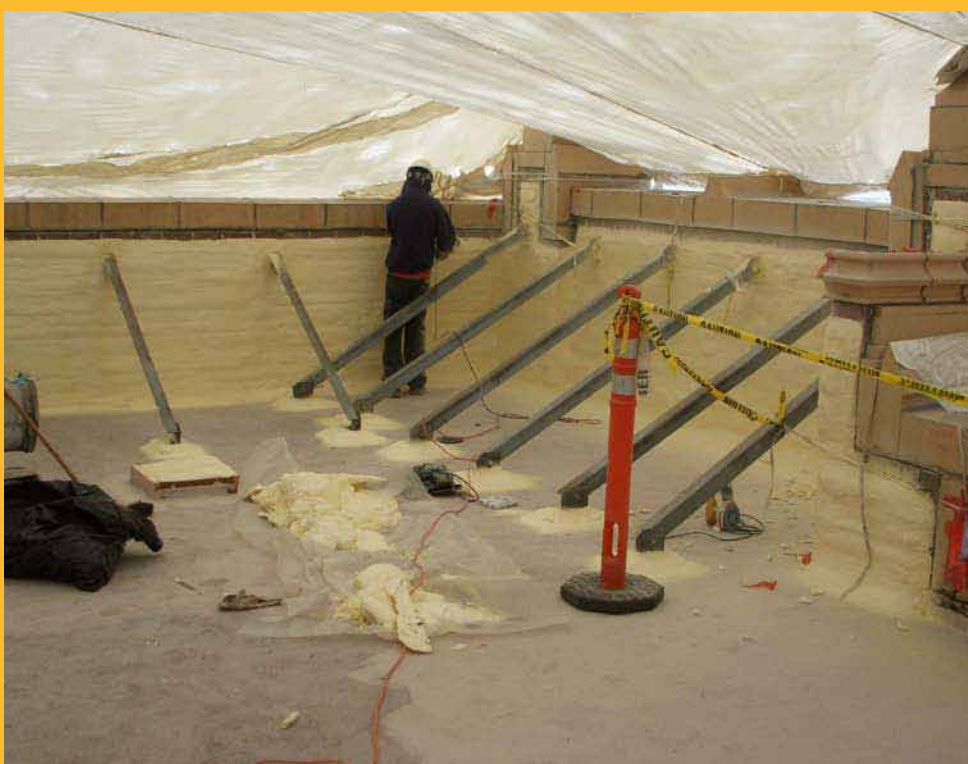
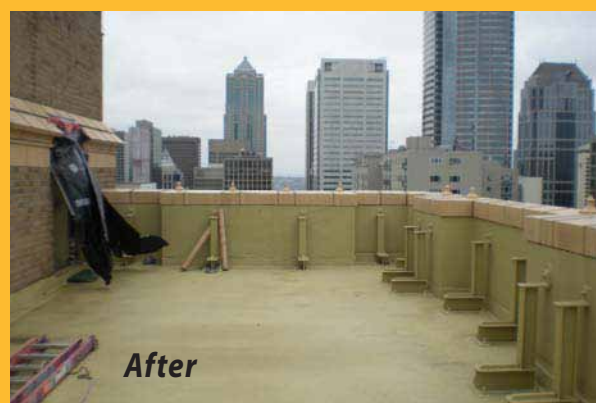
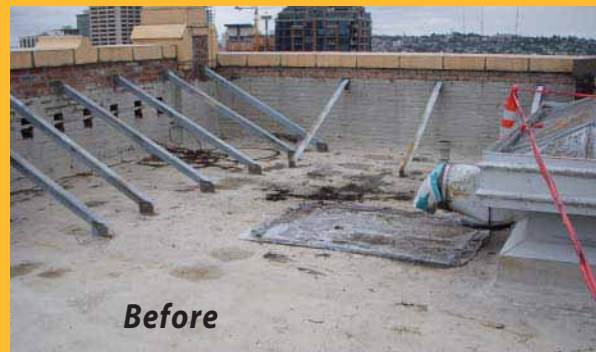
The original failing roofing material was removed, leaving exposed concrete and bitumen residue. The transitions included brick parapets, concrete and wood curbing, metal flashing, and cast iron pipe. Polyshield HT-101™ high elongation characteristics allow the coating to encapsulate virtually any shape or size, providing a truly seamless, monolithic coating that seals the substrate and locks out water. The entire roof area was tented or enclosed to ensure the schedule could be met during

the rainy season. Cracks were prepped and filled, then the area was coated with a tar conversion epoxy primer.

Polyurethane foam was used to smooth out the rough parapet wall and for slope correction. Next, the applicator sprayed applied 100 mils of SPI's Polyshield HT-101™ polyurea on the roof, parapet wall, and all penetrations. The applicator then added an acrylic topcoat for U.V. protection.

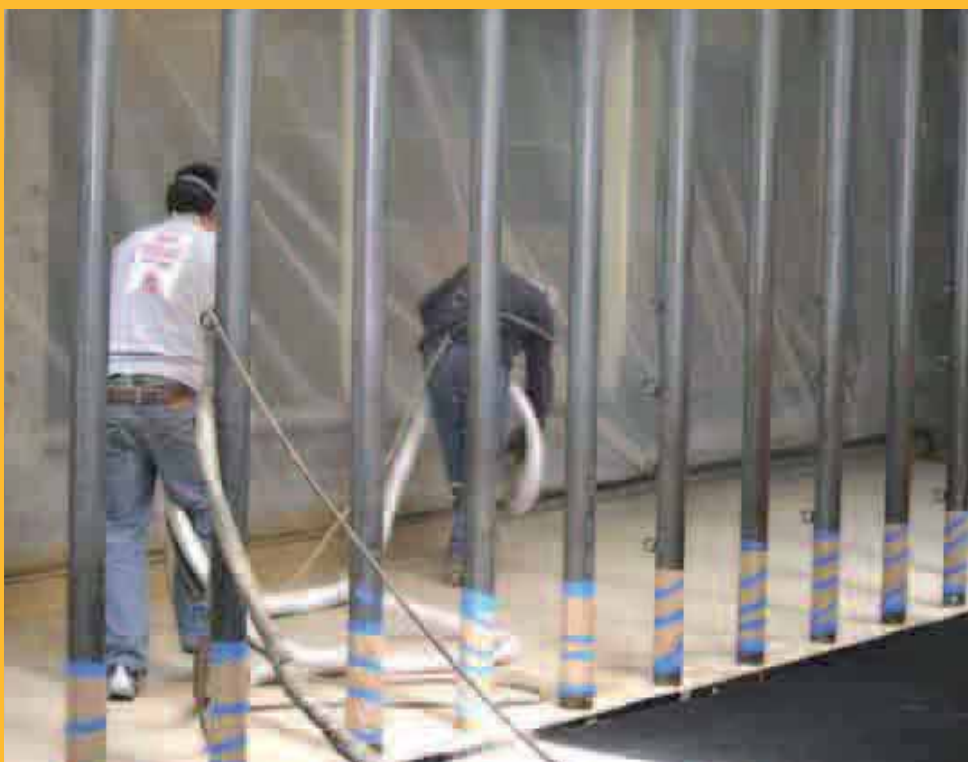
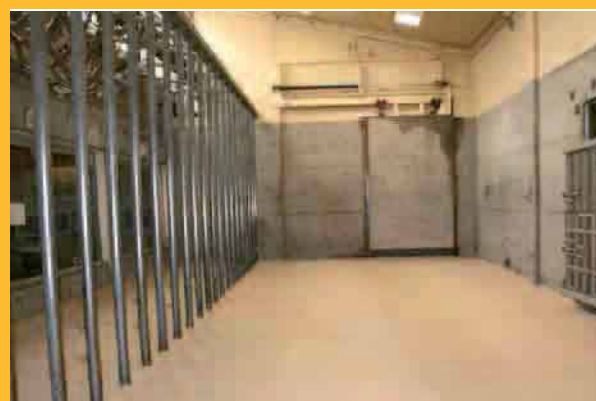
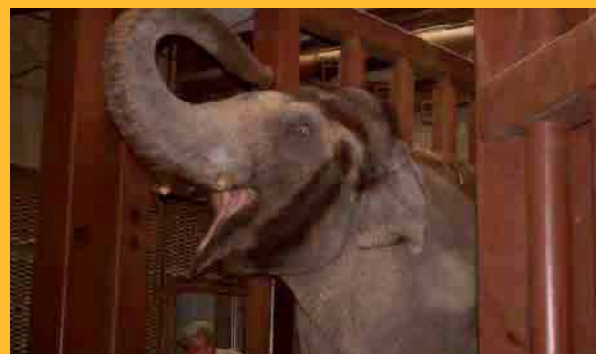
PROBLEM:
In the elephant viewing area, rubber mats over the concrete floor are provided for the elephants to stand on. The mats were coated with urethane to waterproof and protect against wear and tear. This coating became ragged and started to crack. Curious elephants started to pull on the loose pieces of coating. The damaged mats remained wet, and quickly became unsanitary for the elephants and zoo patrons. The zoo needed a new sterile coating to protect the rubber mats from bacteria and waste. It was critical for the coating to withstand high point loading stresses associated with the elephants walking on it.

The old mats were removed and replaced with a ¾-inch thick rubber mat and over-laid with Polyshield HT™ at a thickness of 120-150 mils.

Polyshield HT™ provided a high-strength, resilient coating that can endure the elephant's weight. It also created a seamless protective membrane that resists bacteria and allows for the elephant waste to be easily cleaned several times a day with high pressure water hoses.

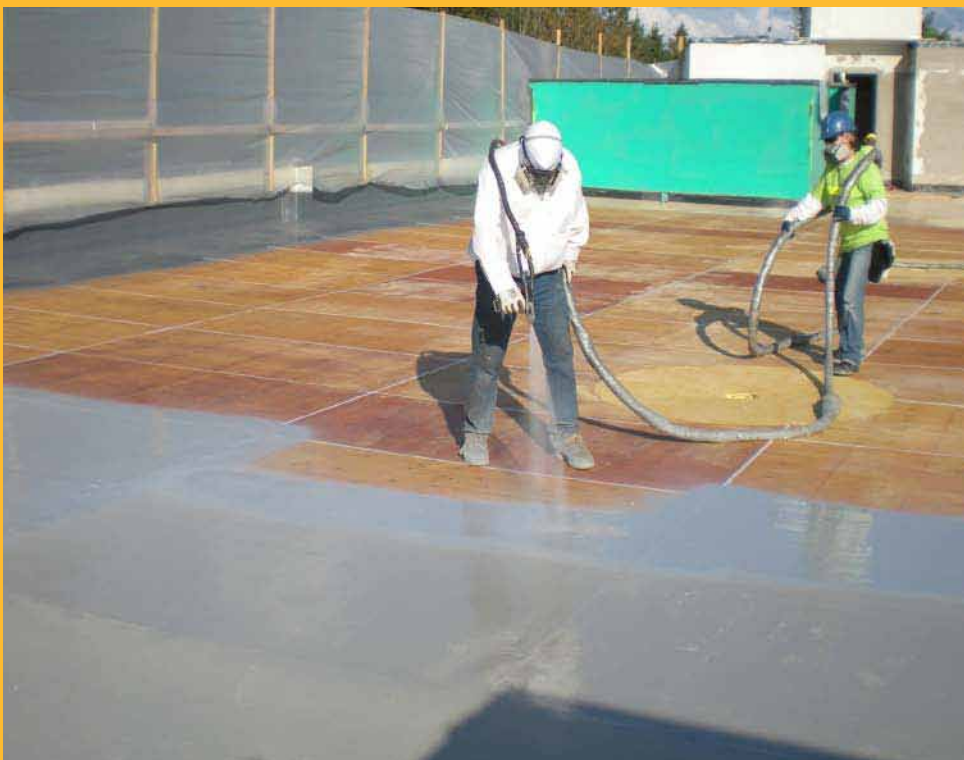
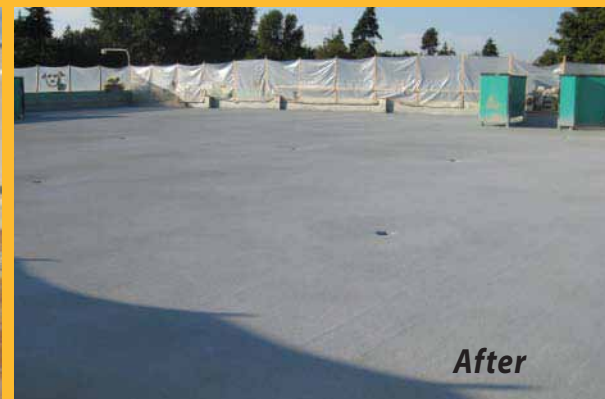
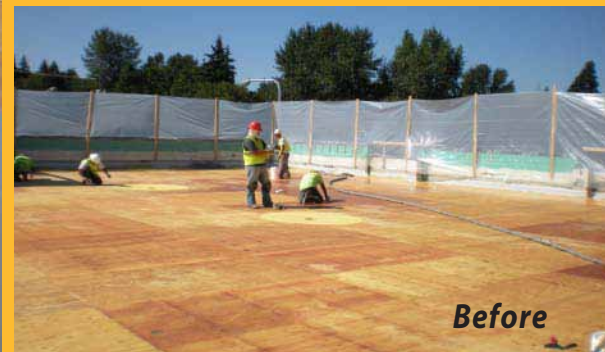
The applicator was contracted to provide a solution over the existing tar coating. Vector Construction and SPI devised a system of installing two layers of 3/4 inch fire rated plywood over 4 inches of 100 lb. compressive strength foam, applied on top of the original

tar coated concrete. The new solution had to be a "floating" roofing system because it could not be mechanically attached to the concrete deck.

Next, the protection mat, foam insulation, and drain mat were removed while pull tests were completed for wind uplift calculations. Each layer was then glued in place with two layers of structural plywood on top of 8.0 lb. density polyurethane foam. The polyurethane foam was used for sloping around drains & transitions. The applicator applied 100 mils of Ultra Bond-HT™ polyurea to the roof, parapet wall, and all transitions. Aluminum oxide was broadcast into the coating, and a final topcoat was applied to provide a non-skid surface.
